USAAVRADCOM TR 78-2

AD A 054906 **FIELD EVALUATION OF THE SHOCK PULSE TECHNIQUE TO UH-1H SERIES HELICOPTERS**

5 JUNE 1974

FINAL REPORT

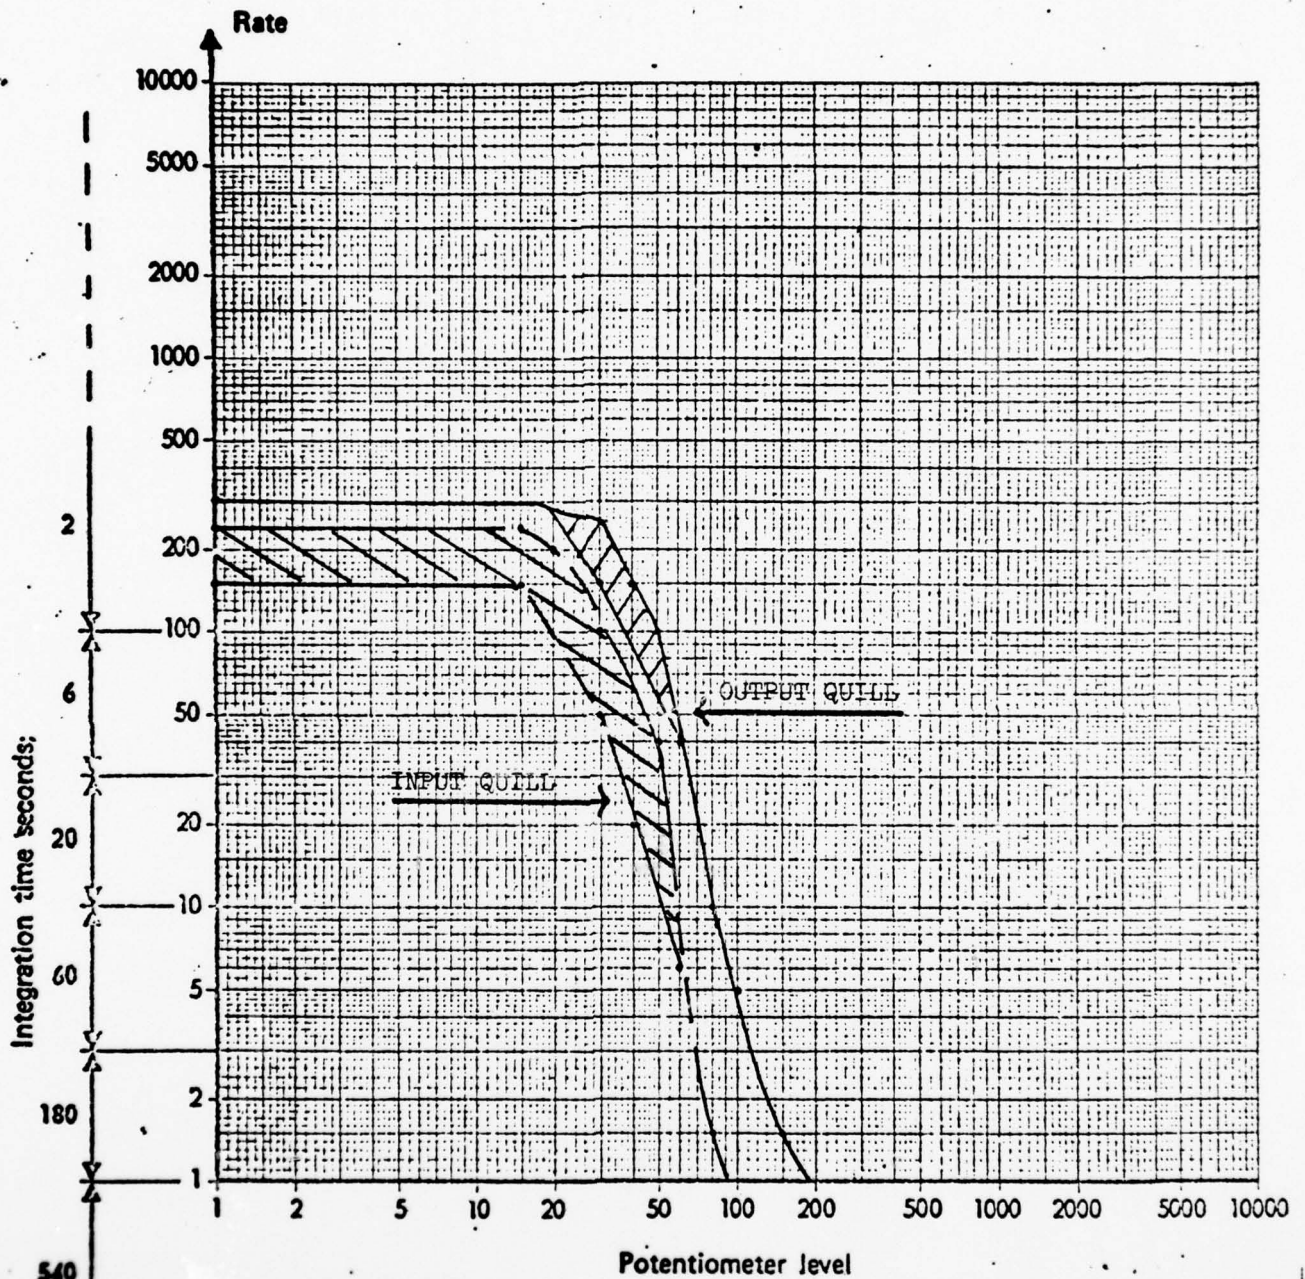
ONE CURVE DEPICTS INPUT DRIVE QUILL, THE OTHER OUTPUT DRIVE QUILL.
GEARBOX REMOVED FOR TEARDOWN ANALYSIS.

Shock emission profiles for both input and output quill packages had some needle swing which was the main reason for removing this gearbox for teardown. There is little difference in the curve shapes of both bearing assemblies and neither had abnormally high rate or potentiometer level. The needle swing in rate analysis was felt could have masked curve irregularities related to bearing damage.

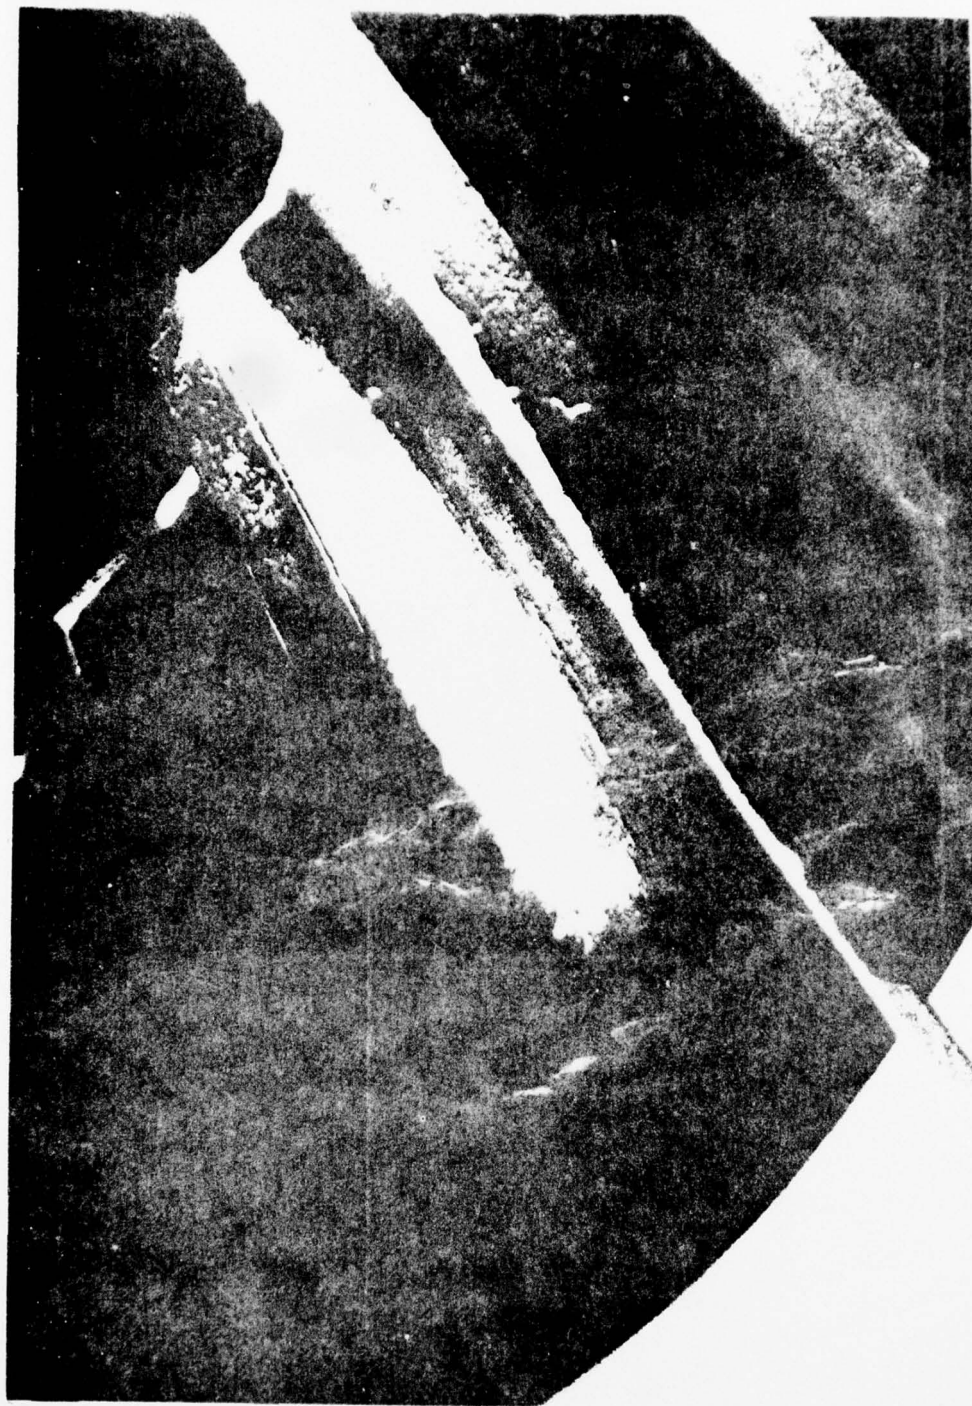
ABB-1101 - Output Gear Pattern.

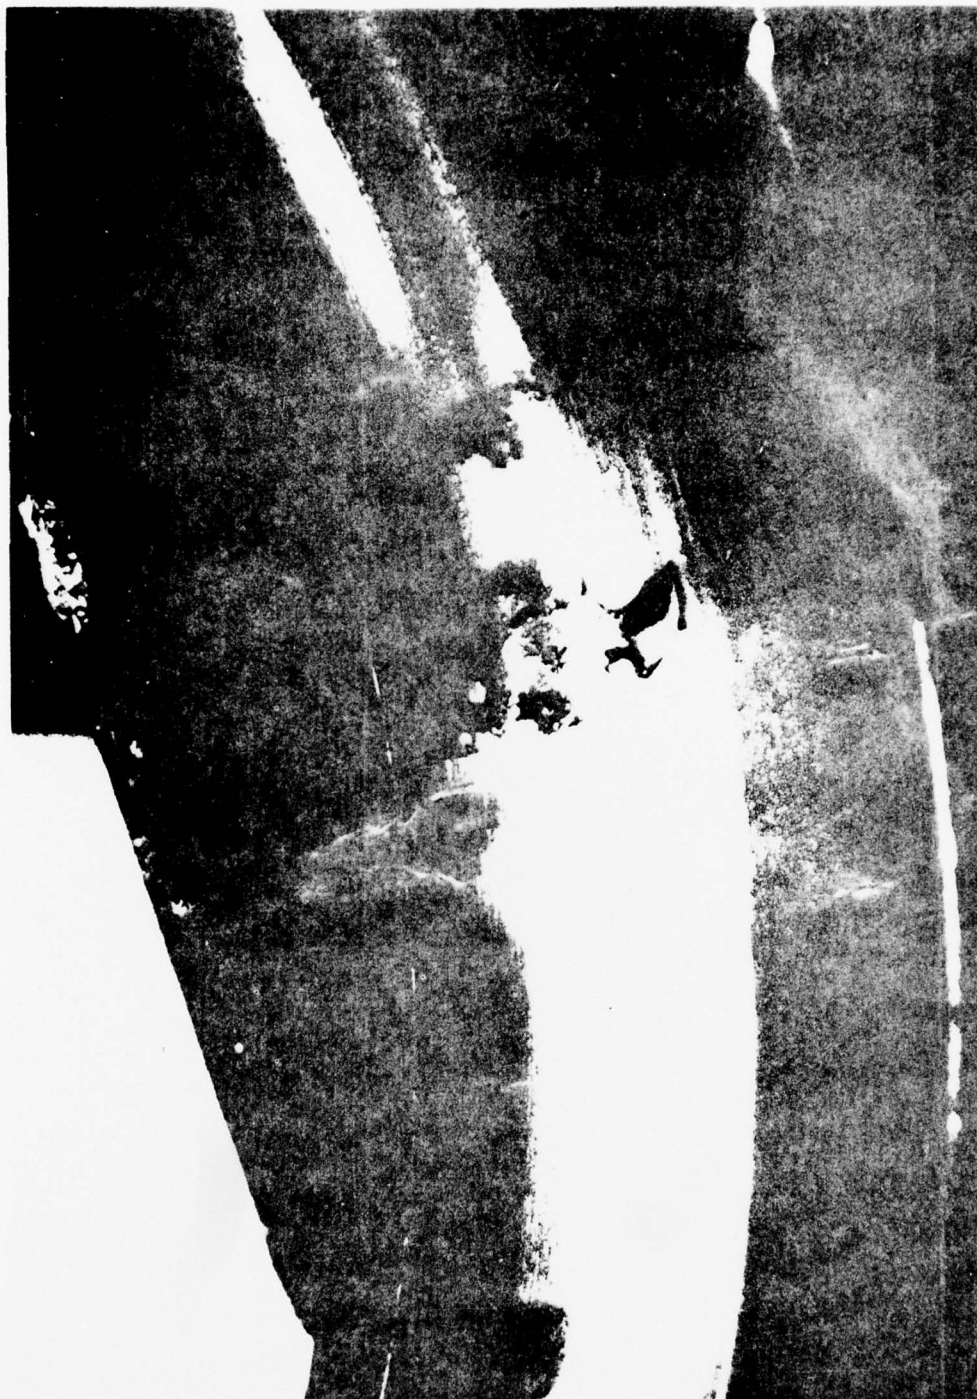
ABB-1101 - Output, Inner Bearing
Corrosion Damage on Outer Race.

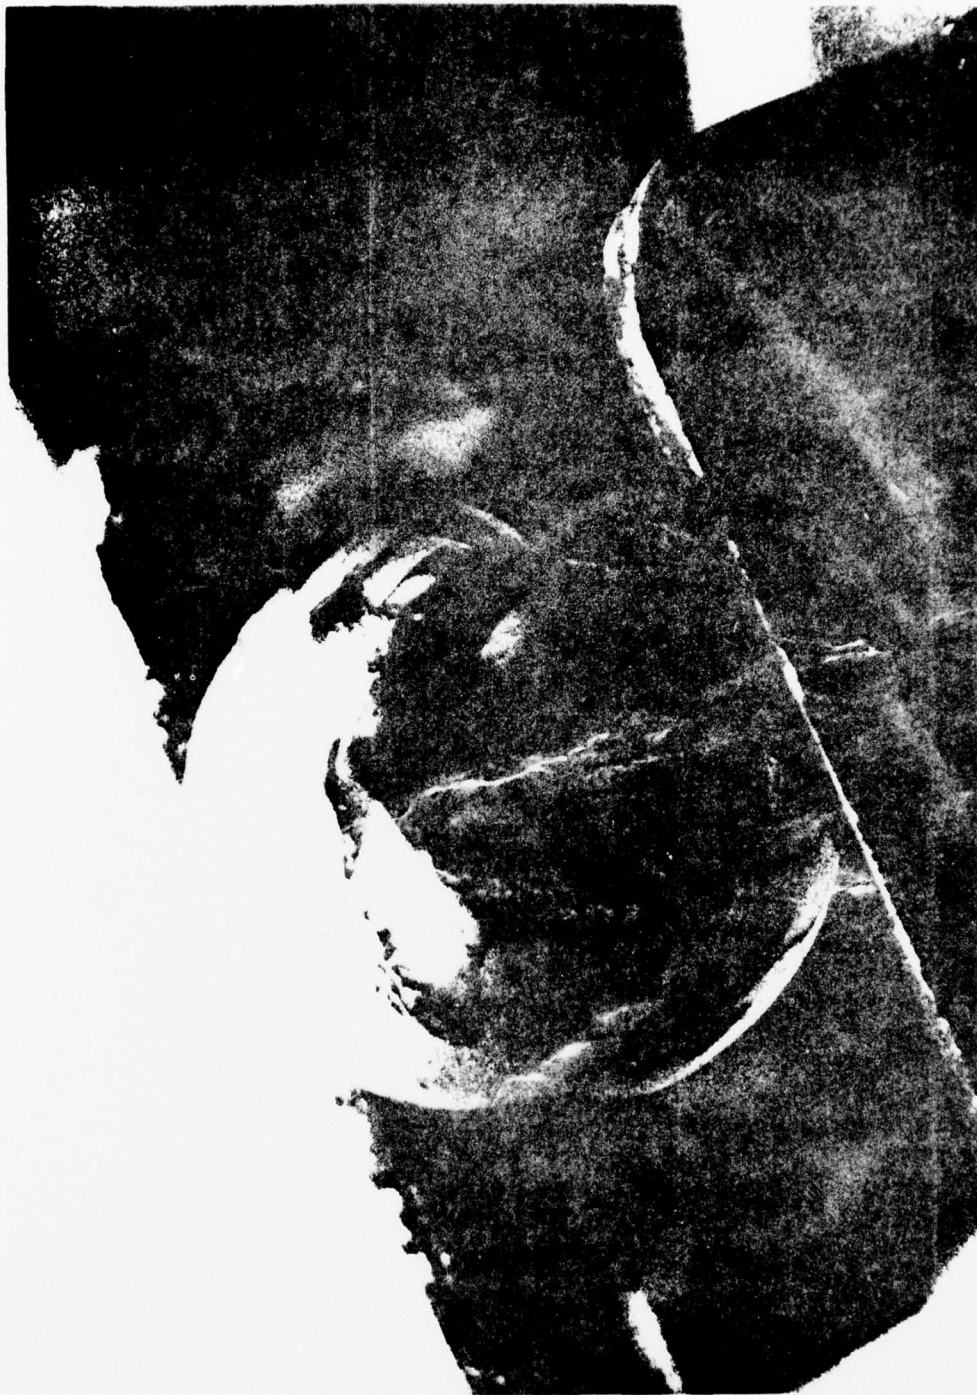
FIG. 38D

ABB-1101 - Output, Inner Bearing,
Corrosion on Ball.

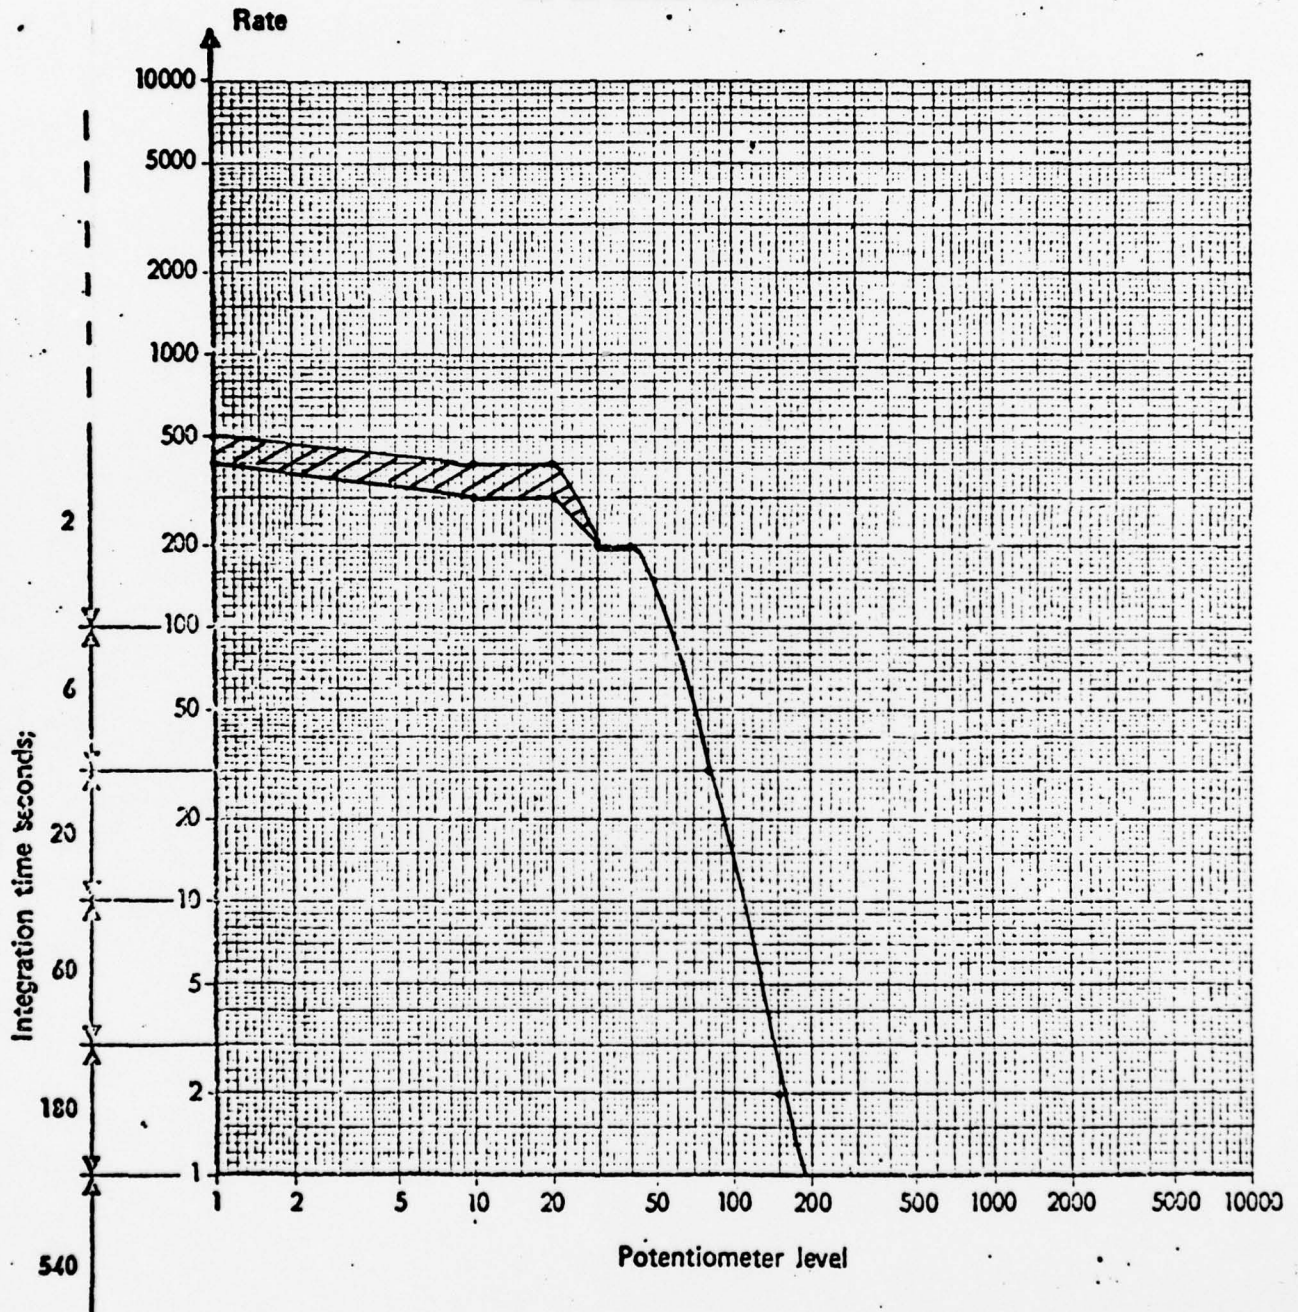
CURVE REPRESENTS THE OUTPUT DRIVE QUILL. GEARBOX REMOVED FOR TEARDOWN ANALYSIS.

The MEPA-10A shock profile of the output bearing of the quill assembly showed some irregularities in the curve shape. Needle swing again accounts for part of the manifested irregularities and the rate of 500 was considered high compared with normal. Teardown information showed that while some damage was evident, no severe damage existed.
